# Manhole Inspection Summary

Manhole # S21A1\_006MH

Insp Date: **6/5/08 10:26 AM**

**Location** Address: **2132 lind st**

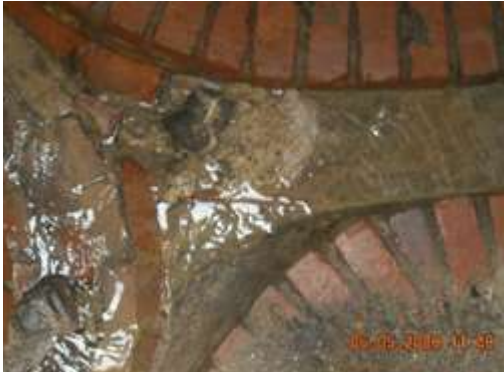
misc

debris in channel and bench

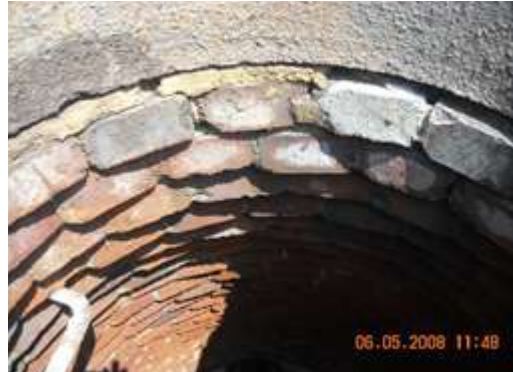
Defect 2

Infiltration: ☐ None ☒ **Joint** ☐ Cracks ☐ Mortar ☐ Roots ☐ Wall

infiltration @ corbel/frame joint

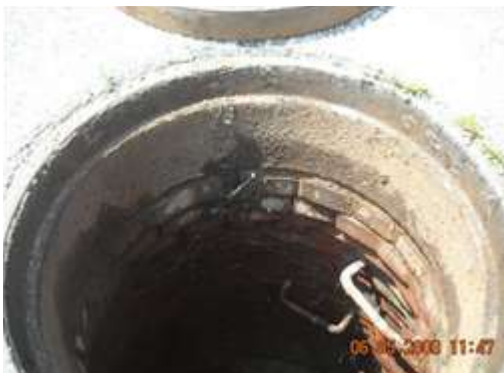
Defect 1

Subject To Ponding: **Sheeting**

☒ **Leaks**

frame leaks-inflow evidence from sheeting
